TYRONE RESERVOIR 1

National Dam Inspection Program.
Tyrone Reservoir 1 (NDI ID 536),
Susquehanna River Basin, Sink Run, Blair
County, Pennsylvania.

PHASE I INSPECTION REPORT.

TYRONE RESERVOIR NO. 1
NDI I.D. NO. 536
JULY 11, 1978

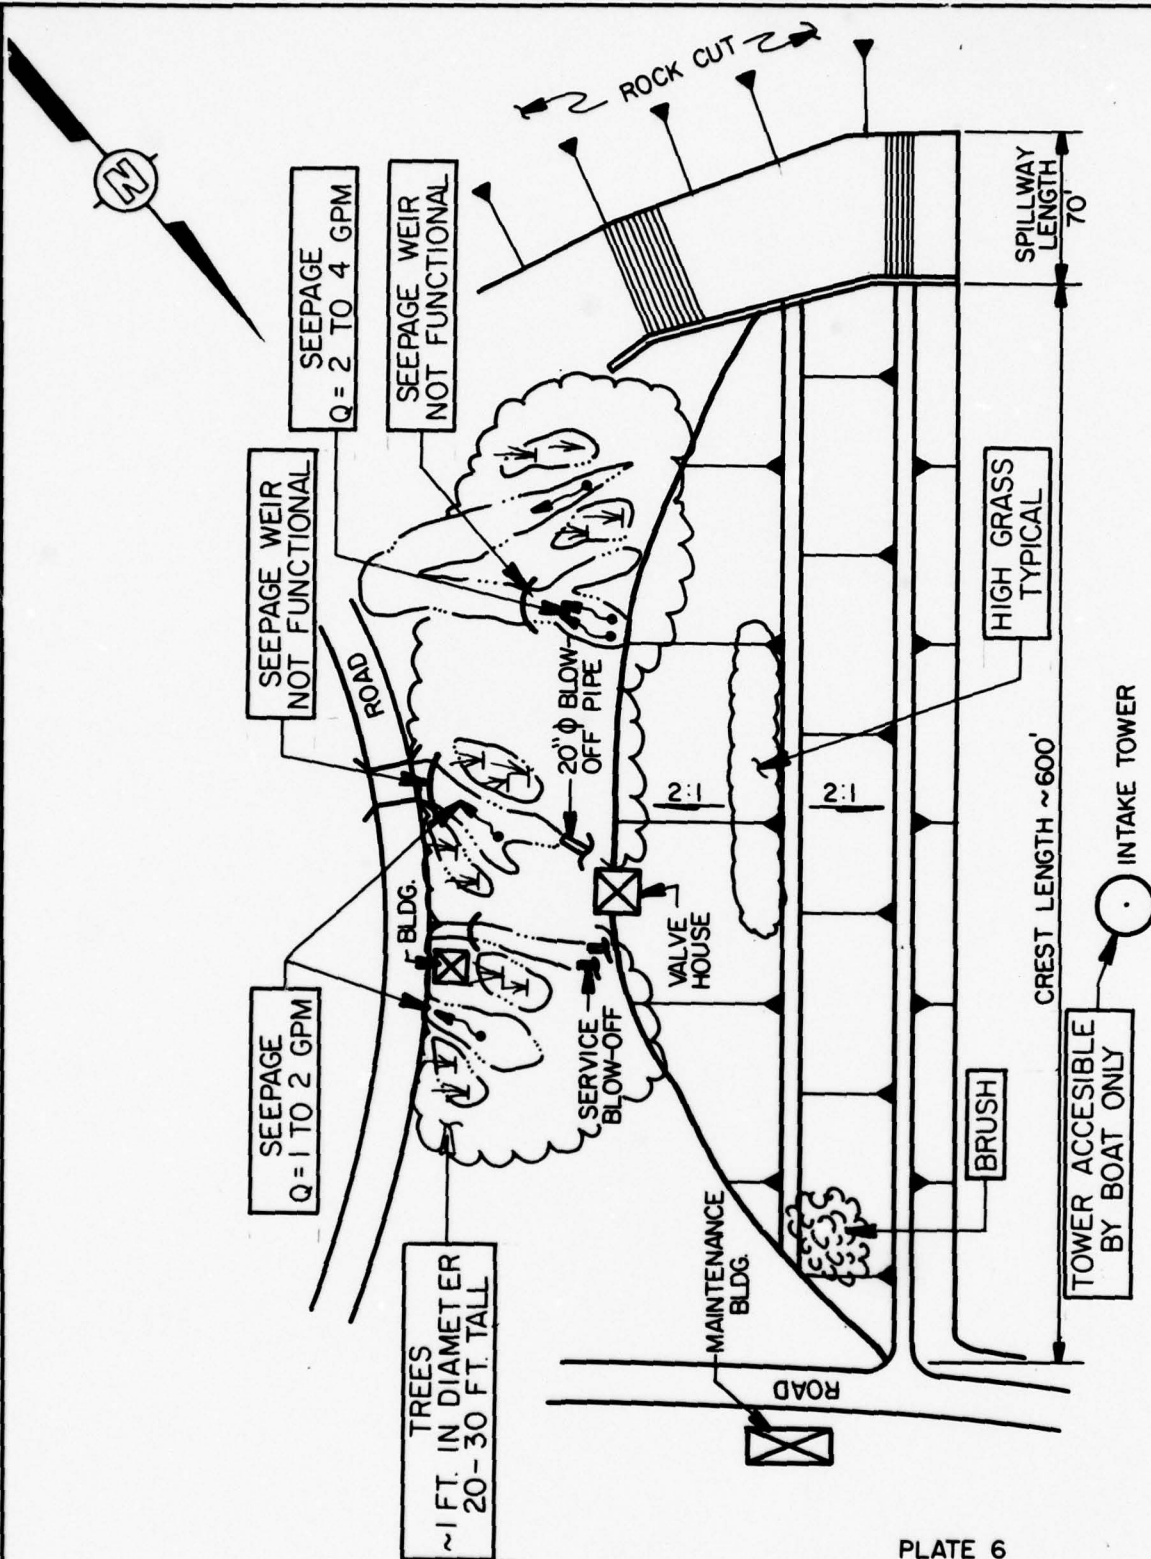
PLATE 6
 TYRONE RESERVOIR #1
 GENERAL PLAN
 FIELD INSPECTION NOTES
 FIELD INSPECTION DATE: JULY 11, 1978

1. Numerous wet areas and three seepage areas were observed below the toe of the dam. The seepage flows were estimated to be in the range of one to four gallons per minute as shown in Plate 6.
2. The downstream face of the dam was found to be covered with high grass which should be mowed annually.

VISUAL EXAMINATION OF	OBSERVATIONS	REMARKS OR RECOMMENDATIONS
JUNCTION OF EMBANKMENT AND ABUTMENT, SPILLWAY AND DAM	NO VISUAL SIGNS OF DISTRESS, NO SEEPAGE	
ANY NOTICEABLE SEEPAGE	SOME WET & SWAMPY AREAS BELOW TOE. SEEPAGE MINOR Q21 TO 4 GPM	SEE PLATE 6 FOR LOCATION OF SEEPS.
STAFF GAGE AND RECORDER	NONE	
DRAINS	NONE

VISUAL EXAMINATION OF	OBSERVATIONS	REMARKS OR RECOMMENDATIONS
MONUMENTATION/SURVEYS	NONE	
OBSERVATION WELLS	NONE	
WEIRS	THREE ABANDONED SEEPAGE WEIRS. SEE PLATE 6 FOR LOCATION.	THIS PAGE IS BEST QUALITY PRACTICABLE FROM COPY FURNISHED TO DDG
PIEZOMETERS	NONE	
OTHER	NONE

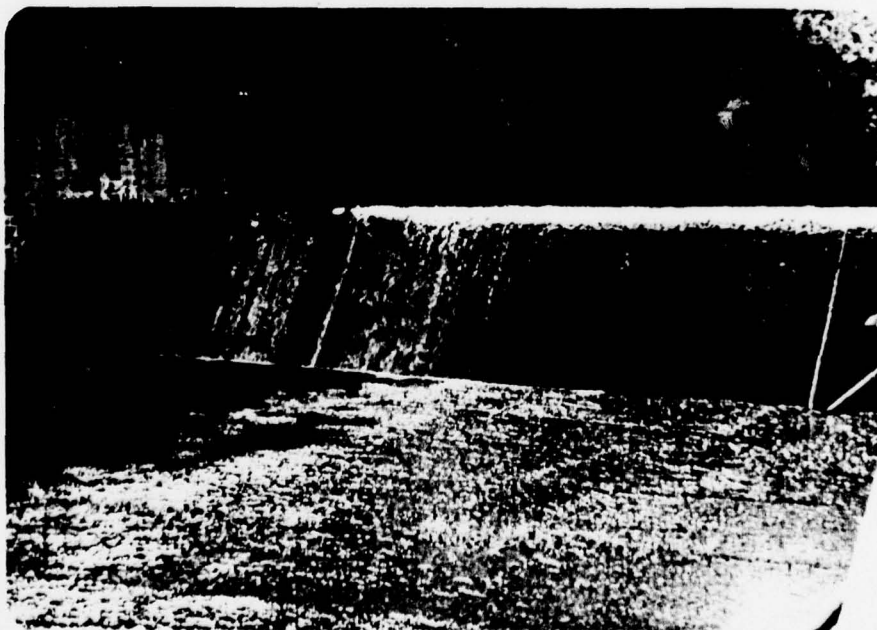
Photograph No. 2

Spillway crest.

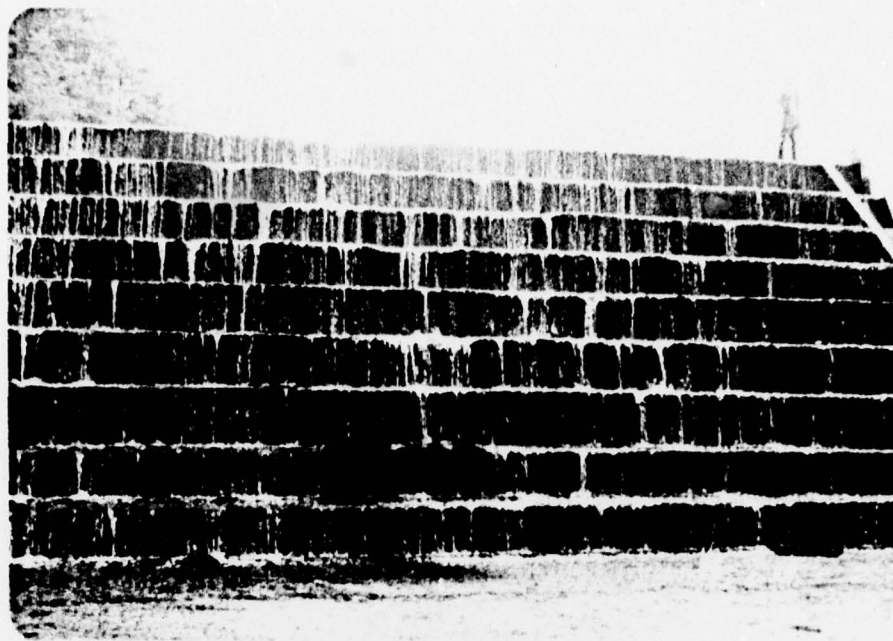
Photograph No. 3
Spillway discharge channel.

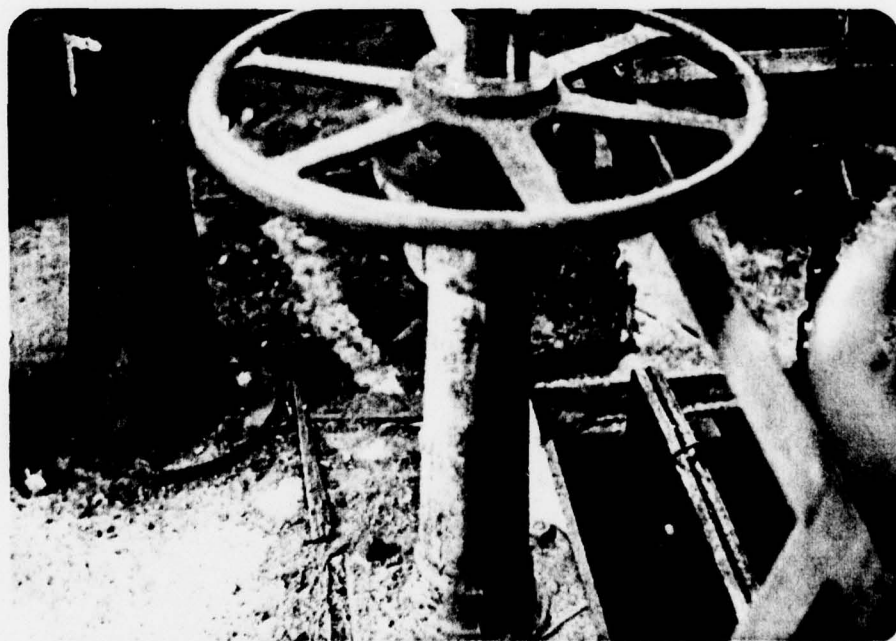
4.3 Maintenance of Operating Facilities. Borough personnel reported that the blow-off valve for the dam is not functional. Visual observations indicate that the operating equipment is in poor condition. The intake tower where the upstream valves for the blow-off pipe are located has no bridge; it is only accessible by boat.

Photograph No. 4
Gate control at intake tower.

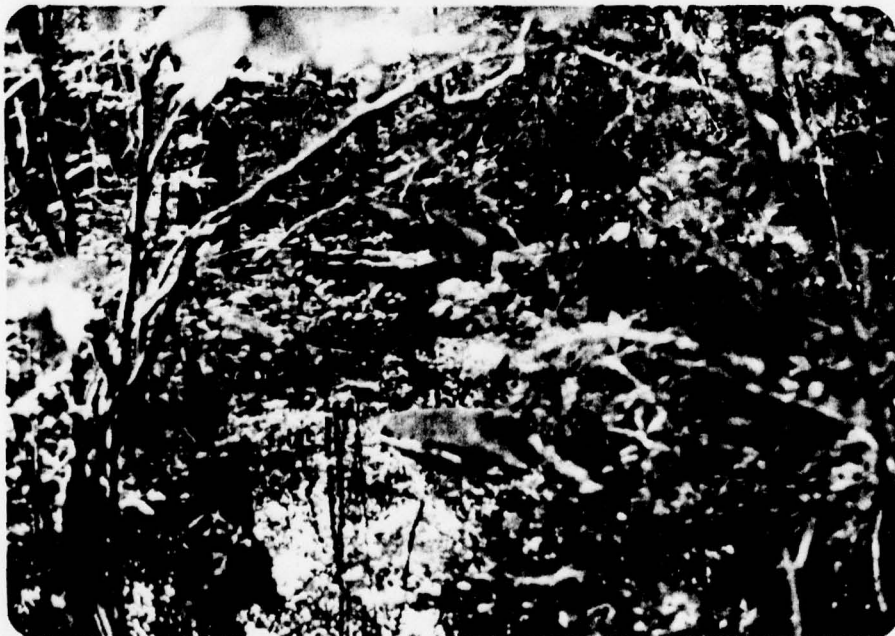
3.2 Evaluation. General condition of the dam is considered to be fair. The extent of the wet areas below the dam raises some concern as to the effect of the seepage through the dam on the stability of the embankment. The owner should monitor and record seepage quantities and observe the turbidity of the seeps.

Photograph No. 6
Seepage at toe (note abandoned seepage weir).
